DESIGN <i>AB</i>	DRAWN BY <i>AB</i>	DART AEROSPACE LTD HAWKESBURY, ONTARIO, CANADA	
CHECKED <i>PH</i>	APPROVED <i>MM</i>	DRAWING NO. DSI 9369	REV. A SHEET 1 OF 1
DATE 07.02.13		TITLE STRUT REPLACEMENT	SCALE NTS
A	07.02.13	NEW ISSUE

DART SERVICE INSTRUCTION

TO AMEND INSTALLATION INSTRUCTIONS D206-540 Rev. I

D206-540-013 INSTALLATIONS

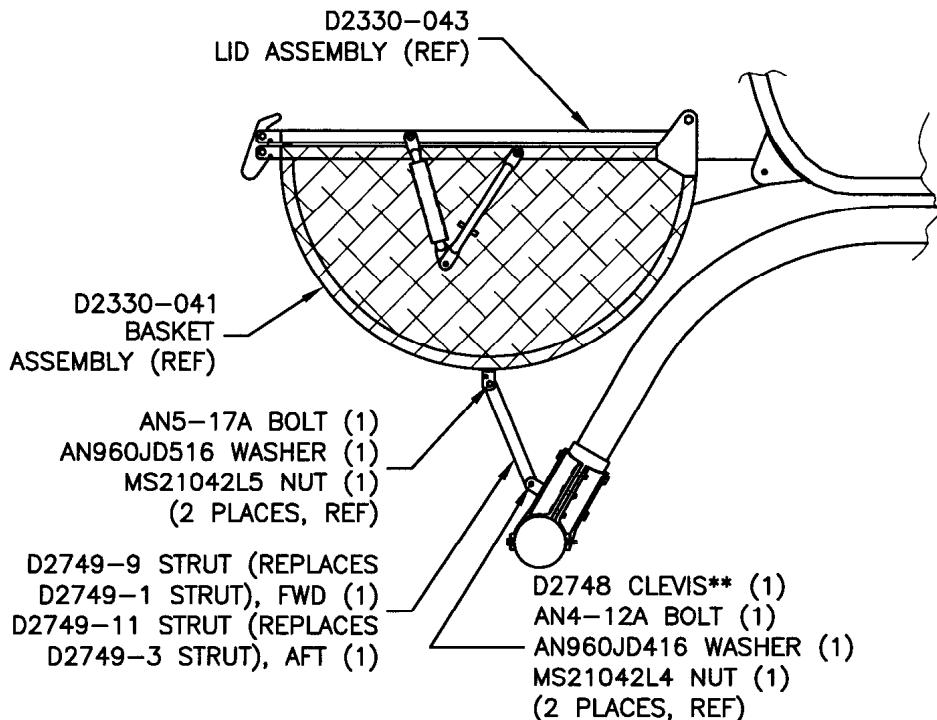
To eliminate interference with the forward hinge of the basket and the door, and to correct the length of the forward strut, it is acceptable to replace the D2749-1/3 Struts with D2749-9/11 Struts on some D206-540-013 Heli-Utility-Basket installations as shown below.

**NOTE:
REPLACE EXISTING SADDLE WASHER WITH D2748 CLEVIS AND
RE-ATTACH USING EXISTING SADDLE HARDWARE.
